**Antelope Guzzler Report**  
**Hatch Guzzlers Maintenance Report 2012**

**Summary of Maintenance and Repair Needs**

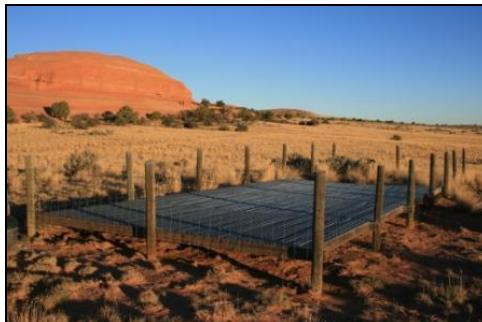
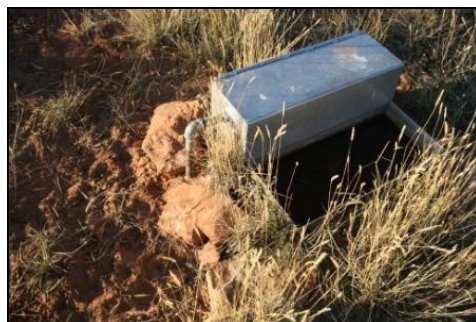
**No Soup Rock-UDWR**

**2012** – System was turned on in the spring and turned back off in the fall when the cows returned to the range. Sediment box was pumped out, cleaned and inspected. Storage tank has water and system is in good shape. Aluminum drinker has been damaged by cows and will soon fail, needs replaced.

**2011** –Shut-off valve was malfunctioned, a new valve was installed. **2010**- New gutter system and drip edges was installed, catchment repaired, brush. Storage tank has water. **2009**- **Storage tank has water.**

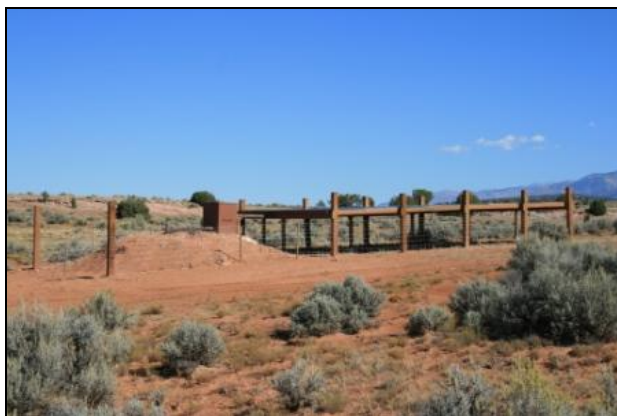
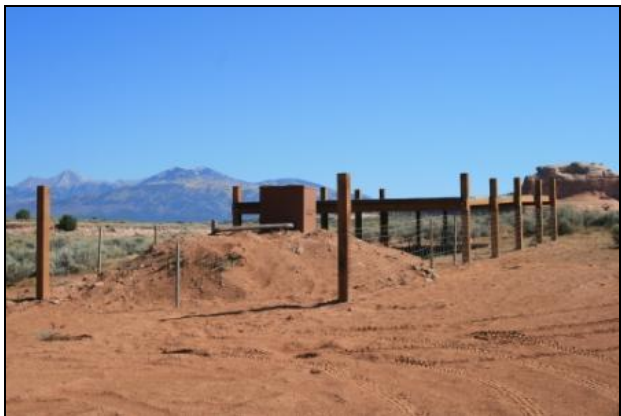
**New Hatch Looking Glass (Installed 2008 DWR funding)**  
**No BLM Rights-of Way**

**2012** – System was turned on in the spring and turned back off in the fall when the cows returned to the range. Sediment box was pumped out, cleaned and inspected. Storage tank has water and system is in good shape.

*2011, 2010, 2009- Storage tank has water and in good working order*

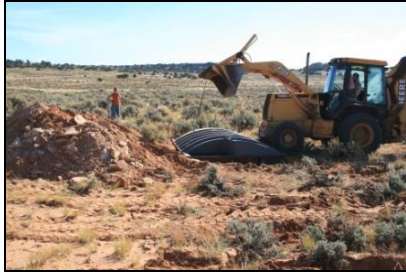
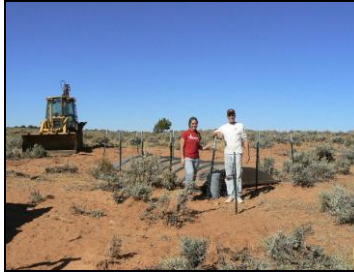
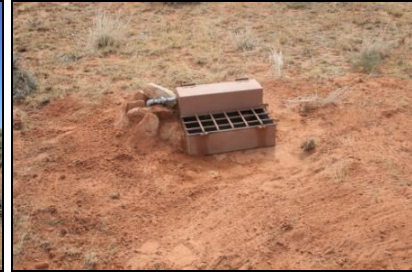
*Removed Saucer System*

***2011** – New Boss tank has plenty of water and new system is working great. **2010-** Saucer catchment system removed & installed at Little Canyon desert bighorn sheep guzzler. Stone Energy, Don Hamilton, Environmental Consultant for Stone Energy and Charley Harrison with Harrison Oil Field Services help us install a 1,700 gallon Boss wildlife guzzler A drinker was plumbed in, the tank was fenced and the disturbed area heavily seeded. Heavy rainstorms the following week put the system on-line again.*
